Recovery After Explosion

INDIANA GRAIN HANDLER ADDS SOME NEW STORAGE, PERFORMS EXTENSIVE REPAIRS

Co-Alliance, LLP
Avon, IN • 317-745-4491

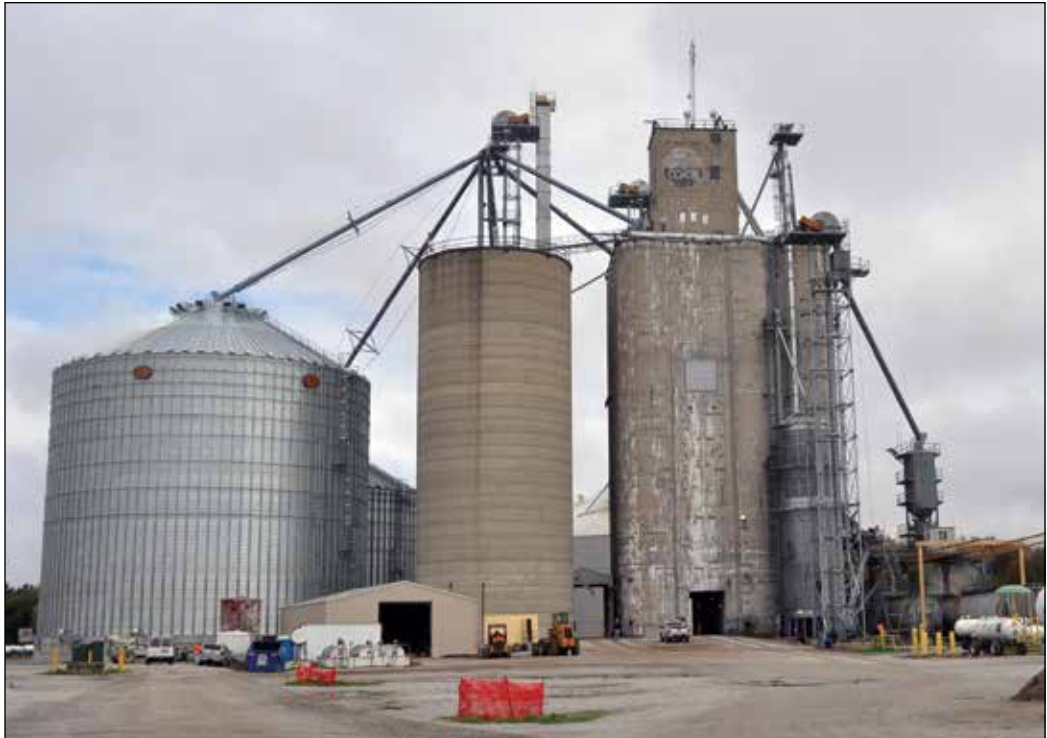
Co-Alliance, LLP's 3.1-million-bushel grain elevator at Union Mills, IN, a little over a year after an explosion damaged portions of the concrete workhouse and adjacent grain dryer. The 700,000-bushel GSI steel tank at left is new. Photos by Ed Zdrojewski.

That wasn't the case a little over a year ago, after an explosion ripped through the headhouse atop the 1968 slipform concrete workhouse at Union Mills. No cause was ever determined for the blast that occurred June 24, 2013.

The explosion destroyed two inside legs and a manlift. Also destroyed was the roof over three tanks inside the slip. Only one of three receiving pits were operational, and one of two grain dryers was damaged by falling debris.

“But, after the concrete headhouse was inspected by River Consulting, Columbus, OH, the engineers found that aside from the normal 45 years of wear and tear, the concrete headhouse was deemed structurally sound, and it was determined to repair what we already had.”

Meanwhile, the cooperative hired Carroll Construction Co., Sears, MI (989-382-5650), to clear out the debris, repair the roof and other portions of the concrete structure, and make repairs to the propane-fired, 4,000-bph Zimmerman grain dryer that had been damaged.

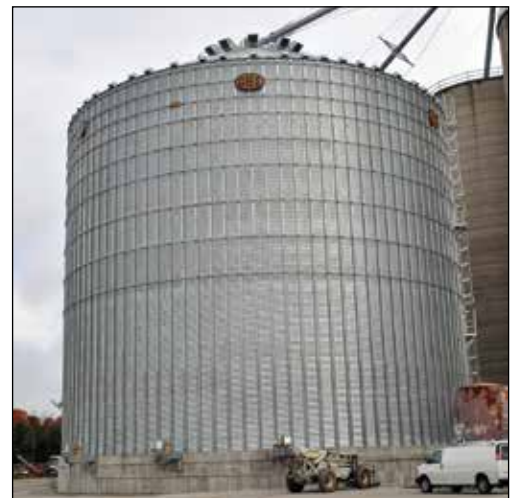
Closeup of the new GSI corrugated steel tank.

The new GSI tank stands 85-1/2

feet tall at the eave, 113 feet tall at the peak, and is 105 feet in diameter. It is equipped with outside stiffeners, flat concrete floor, 12-inch GSI sweep auger, 24-cable Rolfes@Boone grain temperature monitoring system, and BinMaster level indicators. Six GSI 50-hp centrifugal fans provide approximately 1/7 cfm per bushel of aeration through in-floor ducting.

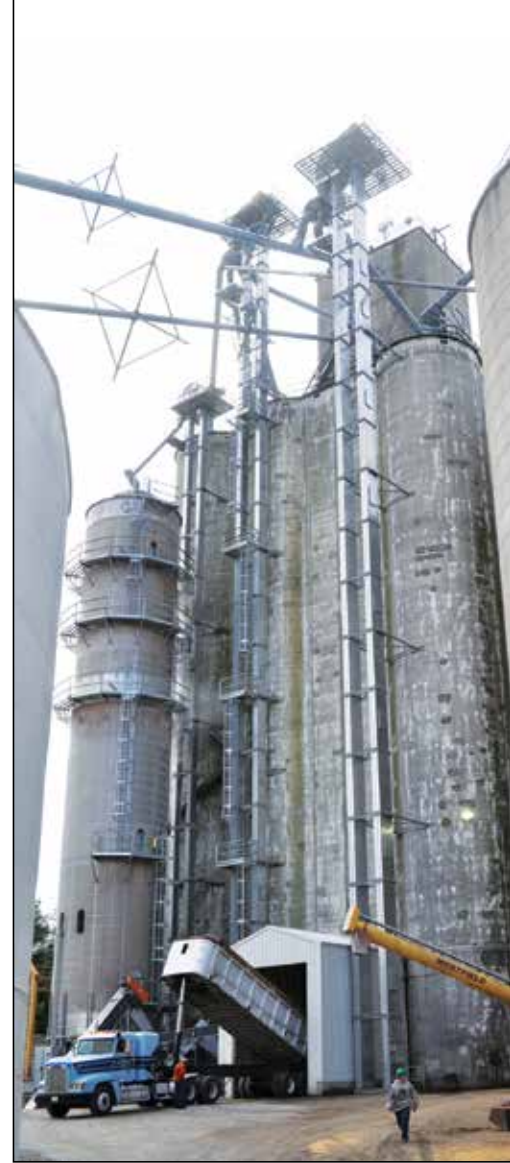
Producer deposits a load of grain into a new receiving pit, which feeds a new 25,000-bph GSI outside leg at right.

Carroll added a new 1,000-bushel enclosed mechanical receiving pit, which feeds a new 25,000-bph GSI receiving leg. The new leg is situated outside of the concrete structure and replaces the two inside legs that were destroyed. The leg is equipped with two rows of Maxi-Lift 14x8 Tiger-Tuff buckets mounted on a 30-inch Goodyear belt supplied by All-State Industries.

The big new leg deposits grain into a new Schlagel six-hole rotary distributor, which can reach most of the concrete house via gravity spout and the rest of the grain storage via overhead GSI 25,000-bph drag conveyors. The new 700,000-bushel bin reclaims into a new above-ground GSI 25,000-bph conveyor running back to the new rail receiving pit.
